**Interior Illumination of the
University of Illinois Auditorium**

INTERIOR ILLUMINATION OF THE
UNIVERSITY OF ILLINOIS
AUDITORIUM

THESIS

ELECTRICAL ENGINEERING

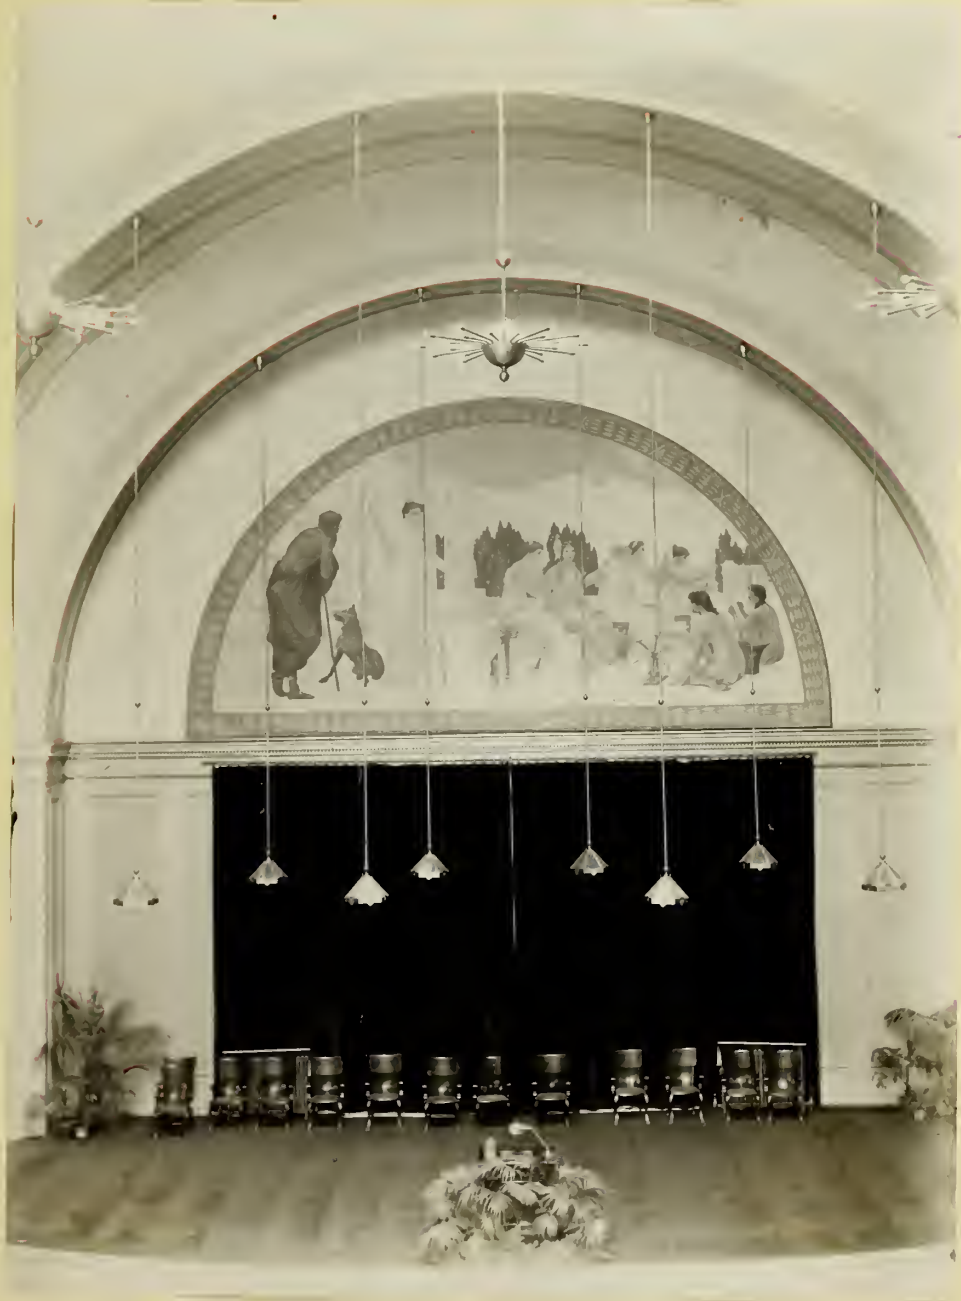
Perhaps the greatest objection to the present fixtures over the stage is from the artistic standpoint. As will be seen from the photo on page 4, these fixtures are suspended by very long straight rods from the arches over the stage. While the long rods are undoubtedly out of place in the Auditorium where long curved lines predominate, the worst effect is on the beautiful painting of The Return of Ulyses by Millet which is in the arch over the stage. It is especially noticable from the balcony that these long rods give the appearance of bars before the painting and in imagination the figures almost become animals in a cage. Thus it is seen that it is certainly most desirable that the rods be removed and the fixtures raised both to give a more uniform illumination on the stage and avoid the spoiling of the effect of the painting.

In the general illumination of the Auditorium from the dome fixtures the lighting is not what it should be.

The present stage fixtures are quite out of place in a building such as the Auditorium; they are too ornate for such surroundings. They would well do in a building like the Library or Lincoln Hall but in the Auditorium they do not harmonize with the massiveness as suggested by the large dome and general construction of everything. In the Library or Lincoln Hall they would be seen by everyone and their beauty could be appreciated. These eight stage fixtures will be removed and placed in the Woman's Building.

Four fixtures with a much shorter drop, hung from the outlets that at present support the front four long fixtures will be substituted. The four fixtures at present hanging from the back outlets are within three feet of the back of the stage and the light from them is very seldom of any use. Hence these fixtures were thought useless. The four new fixtures to hang from the front arch will be supported by chains since these will harmonize with the curved lines of the arches and the entire dome better than the straight stiff rods. These new fixtures will also be designed with curved sides for the same reason. They will be open at the bottom and a large silver-plated reflector will be hung inside of each so as to throw the light from a 150 watt tungsten lamp downward. In this way practically all the light will be thrown on the stage. The apparent vertical candlepower of each of

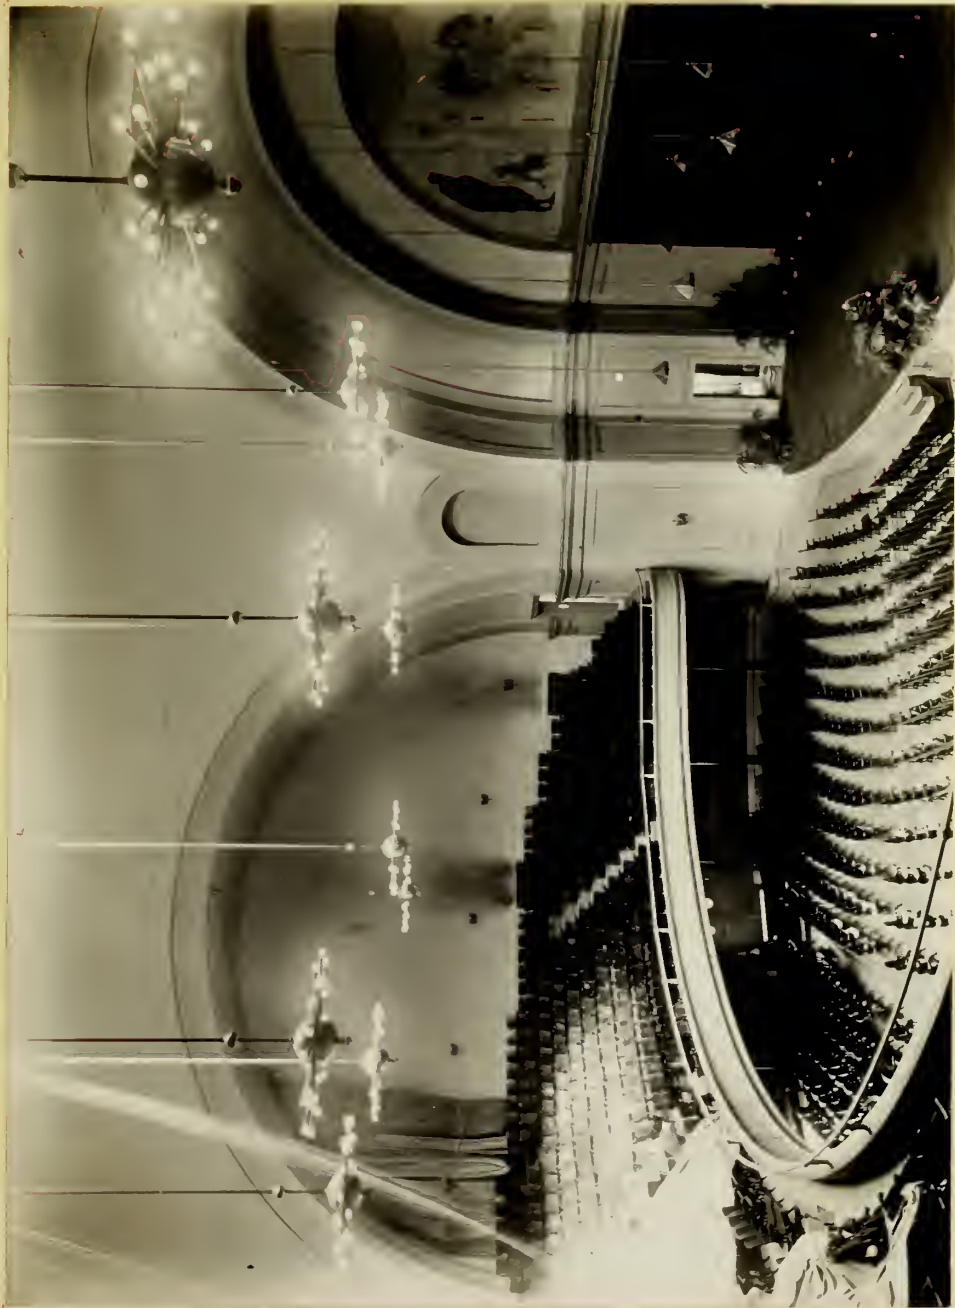
From the illuminometer readings on page 26, it is seen that the intensity on the main floor varies from about 1.15 candlefeet directly under the dome to 0.60 candlefeet at the sides and 0.35 candlefeet under the balcony. This again shows a non-uniformity which would suggest a raising of the fixtures. From the balcony there is another objectionable feature which could be remedied by raising the dome fixtures. At present they are so low that they actually come in the line of vision of those seated in the higher seats of the balcony and this is always to be avoided. The high intrinsic brilliancy of the bare carbon lamps is very injurious as well as tiring to the eyes and if nothing else could be done they should be replaced with frosted lamps to cut down the intrinsic brilliancy. The photo on page 6, taken from one of the higher seats at the side of the balcony, shows the appearance and position of these fixtures.

Again the painting over the stage suffers because of these fixtures. They are all placed in the same plane and the massive balls which form the centers of the fixtures and the large number of arms that carry the lamps cast a ring of heavy shadow all around the walls of the Auditorium. This ring of shadow falls on one of the most delicate parts of the painting and what should be a faintly tinted canopy becomes a heavy dark mass. This too could be remedied by raising the fixtures and not necessarily putting them all in the same plane. The illumination in the balcony is fairly uniform, varying from an intensity of 0.60 candlefeet in the back parts to about 1.10 candlefeet near the front and 0.85

candlefeet at the sides. Both for these specific reasons and for general effect it would be desirable to raise the fixtures a great deal and perhaps redesign them for better efficiency. As it is half of the light is thrown to the ceiling and dome and very little of it is reflected. By the proper use of reflectors much less light could be directed to give the same or greater illumination. One commendable feature of the general illumination at present is that the intensity under the balcony is nearly the same as that in front of it. This removes the objectionable feature so often found in places of this kind where the general illumination gives a distinct line of shadow thrown by the edge of the balcony. This is overcome by the soffit lights on the under side of the balcony. These however are not quite as effective as is possible but could be made so by a few more or larger lamps. The original installation here was of frosted lamps as it should be but some renewals have put in bare lamps and the high intrinsic brilliancy is objectionable to those persons sitting in the elevated rear seats of the main floor.

To remedy the faults of the eight dome fixtures it is proposed to raise them to within about six feet of the dome and at the same time redesign them for more efficient distribution. As they are now, nearly one half of the light is wasted and by raising them and using properly designed shades the same light could be thrown on the floor to give better illumination and distribution.

The rods supporting the three chandeliers in the arches over the balcony would also be shortened and the fixtures redesigned with proper shades to give the desired uniform illumination over the balcony. We would not advise that these be changed in the same way as the eight dome fixtures however. By making these three fixtures different from those hanging from the dome the monotony of too many similar fixtures will be avoided.

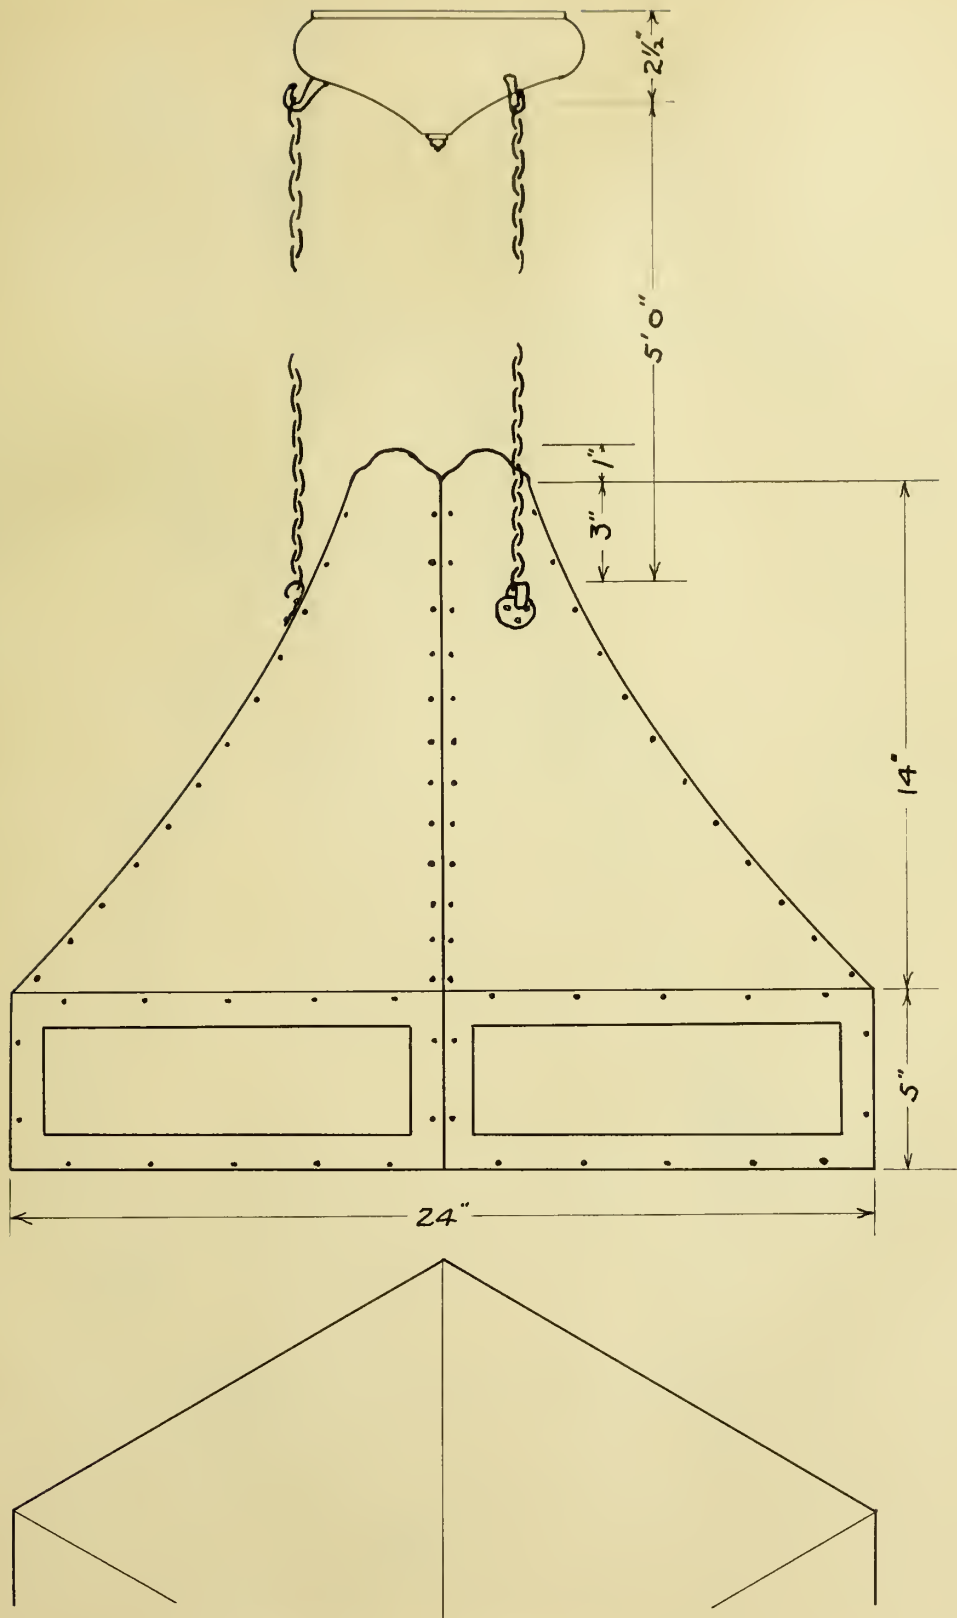
NEW STAGE FIXTURE

The design and construction of the new fixtures for the stage took up a large percent of the time used in the preparation of this thesis. Under the suggestions in the discussion of present conditions and proposed changes a great deal of the design of these fixtures has been determined. It was decided that the fixtures should have a total drop of about six feet. They were to be hexagonal in shape, have an open bottom, have art glass in the vertical part of the shade, and have the slanting part concave. The next step was to make a number of drawings to determine the proper proportions. From one of these drawings a paper pattern was made and a light cardboard shade with tissue paper in place of glass, constructed with the proper dimensions. In order to study the appearance of this in place it was drawn up into the arch by a wire and its proportions studied from below. A few minor changes in the dimensions were decided upon and four other shades constructed of heavy cardboard with dark green art glass in the sides. The drawings on pages 12 and 13 show the dimensions used. Brass paper fasteners with round heads were used as rivets. A galvanized sheet iron form was riveted together and hooks for the supporting chains fastened to this. This form fitted into the top of the cardboard shade and supported the heavy glass reflector and lamp that actually gave the distribution desired.

purpose. This is a type of focusing reflector designed to throw a strong light downward and to the back, and was designed primarily for show window lighting. Page 15 shows the distribution curve of this reflector with a 150 watt tungsten lamp. These reflectors fit inside of the shades and will be turned to throw the light to the back of the stage since they will be hung from the front outlets over the stage. Page 16 shows a photo of one of these fixtures complete with chains and canopy. These chains and the canopy are finished in antique brass and it is expected that the cardboard shades will later be replaced by metal ones to correspond to the chains and canopy. In the cardboard shades a heavy steel wire was put in above the glass to give stiffness to the shade. Page 17 shows several details of the construction of the shade.

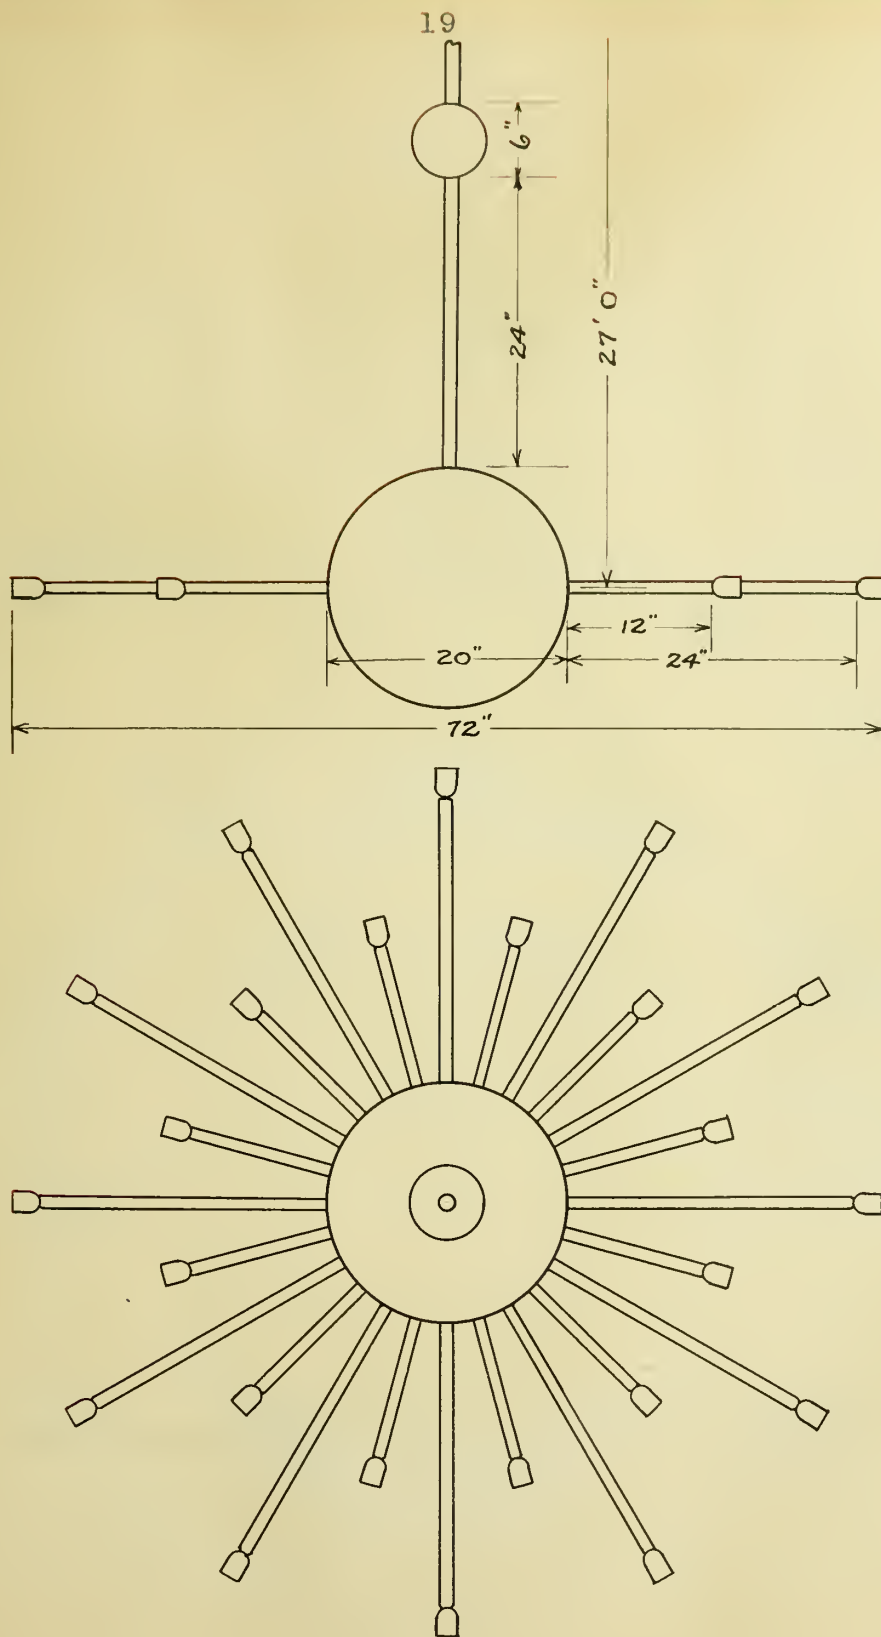
OLD DOME CHANDELIER

In the design of the new dome chandeliers, the old ones will be used to a very great extent. The drawing on page 19 shows one of the old fixtures. Eighteen of the twenty-four arms of each of these will be removed entirely, four of the remaining arms will be left just long enough to support a socket and in each of these will be placed a 40 watt round frosted bulb tungsten lamp. These will serve to enliven the appearance of the fixture and will illuminate the ceiling of the room. On two long arms opposite each other and midway between the lamps just mentioned will be put the two large lamps to give the illumination for the floor. Instead of the horizontal sockets, drop link sockets will be used so that the lamps will hang vertically. 100 watt

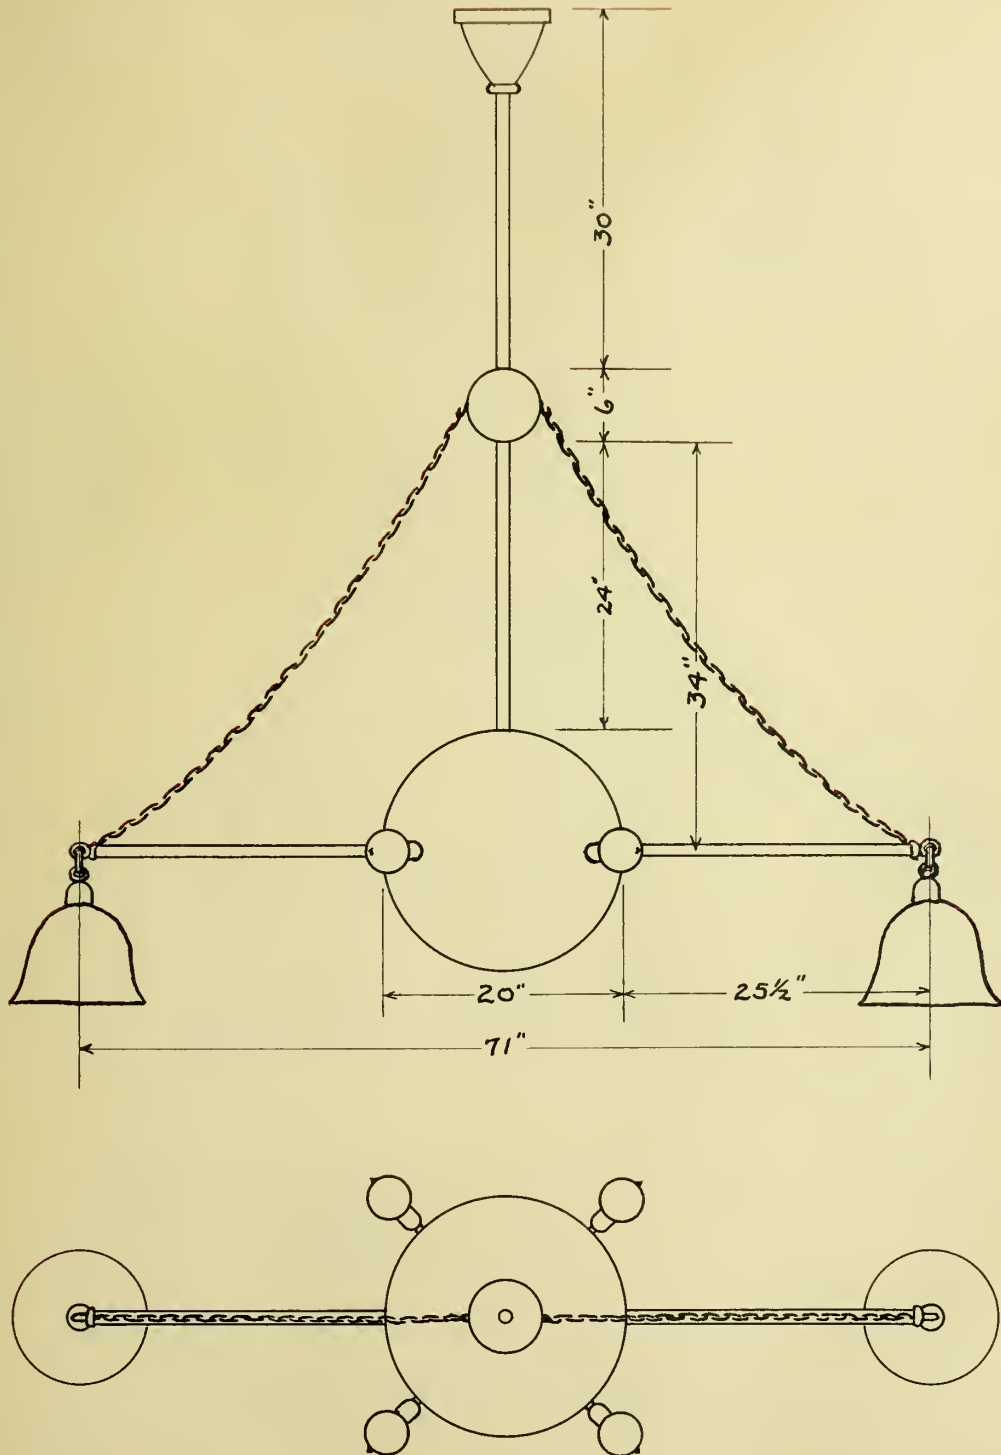
NEW DOME CHANDELIER

clear tungsten bulbs with "Holophane" shades of the intensive type will be used. From the height at which these will be hung, these shades will give the desired illumination on the main floor while the balcony chandeliers and the round frosted bulbs on the dome fixtures will give adequate illumination on the balcony. The two long arms will be supported from the upper ball in the rod by two light-weight chains. These will give a more pleasing appearance to the fixture and will also help support the weight of the shades and lamps at the ends of the long arms. The drawing on page 20 gives an idea of the new design. The eight fixtures will be turned so that the long arms will form a circle around the dome.

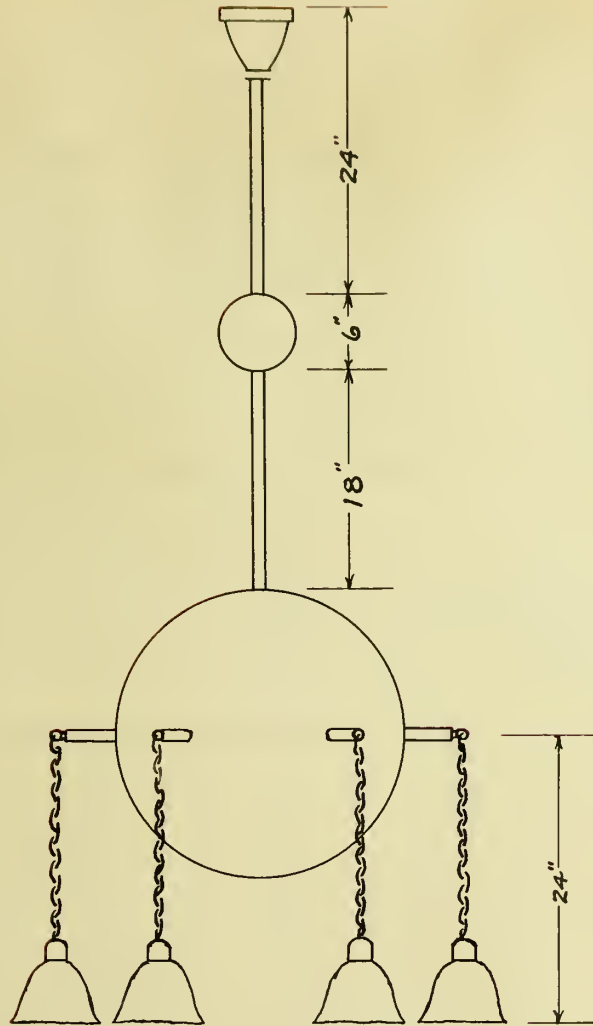
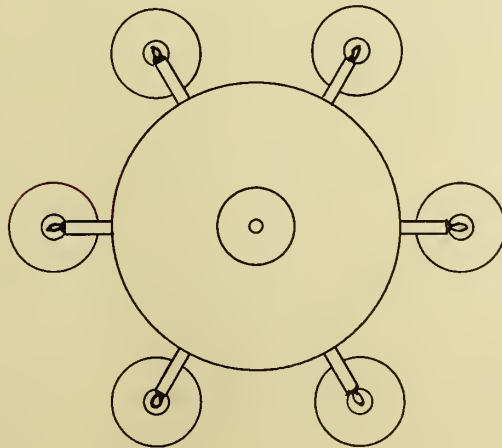
BALCONY CHANDELIER

In the design of the three balcony chandeliers it was decided that a shower effect could be made very artistic in appearance and effective in distribution. These fixtures will also be raised to within six feet of the top of the arches. Six pendant chains from arms about four inches in length, equally spaced around the ball, will be used to support 40 watt frosted-tip tungsten lamps with "Holophane" extensive shades. These drops will have a total length of twenty-four inches. Page 21 shows a drawing of the new design.

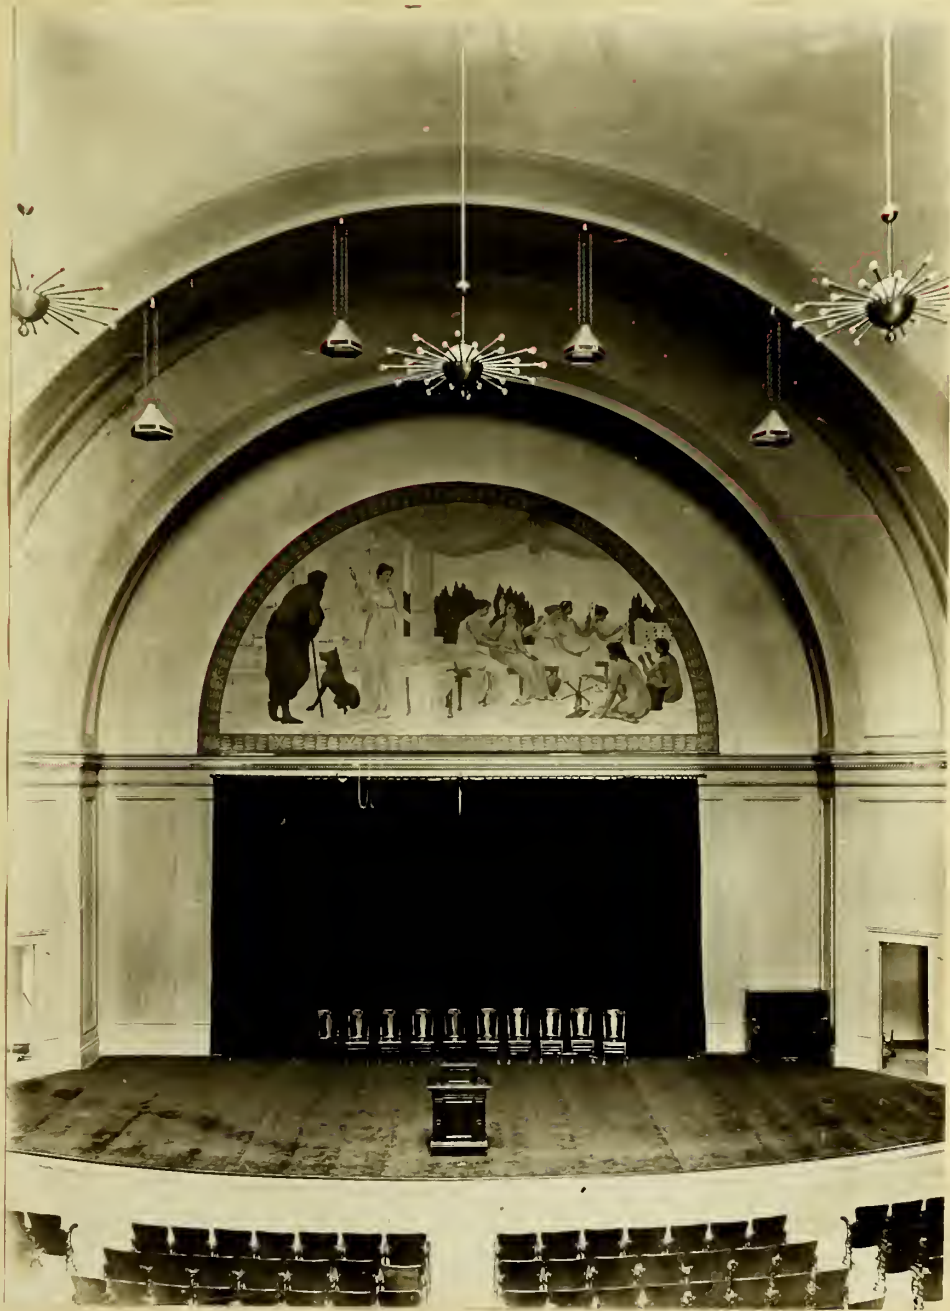
At the time of this writing only the stage lights have been changed. The results from this change have been more than satisfactory. The light on the stage floor is much better and more uniform than before, the intensity now varying from 1.8 candlefeet in the worst position "C", to 2.4 candlefeet near the front center of the stage, this being the position used most. Page 30 gives a comparative table of the intensities before and after the change. It is seen that the illumination in the poorest parts is now better than in the best parts before the change was made as there is now much more uniformity. Page 31 shows the difference in power consumption, there now being required only about 40% of the power used before. The light is whiter and clearer. Fine print can easily be read anywhere on the stage without tiring the eyes, as the illumination is much more satisfactory and more pleasing.

From any place in the seat area the unpleasant light from the old fixtures is gone. The new fixtures are up so high as to be almost unnoticeable to anyone in the audience, especially those on the main floor. This is a very desirable feature in any illumination system. The painting by Millet shows up better than before the old fixtures were taken out, the suggestion of bars in front of the painting is done away with and the whole appearance is very much improved. On page 23 is a photo of the new installation.

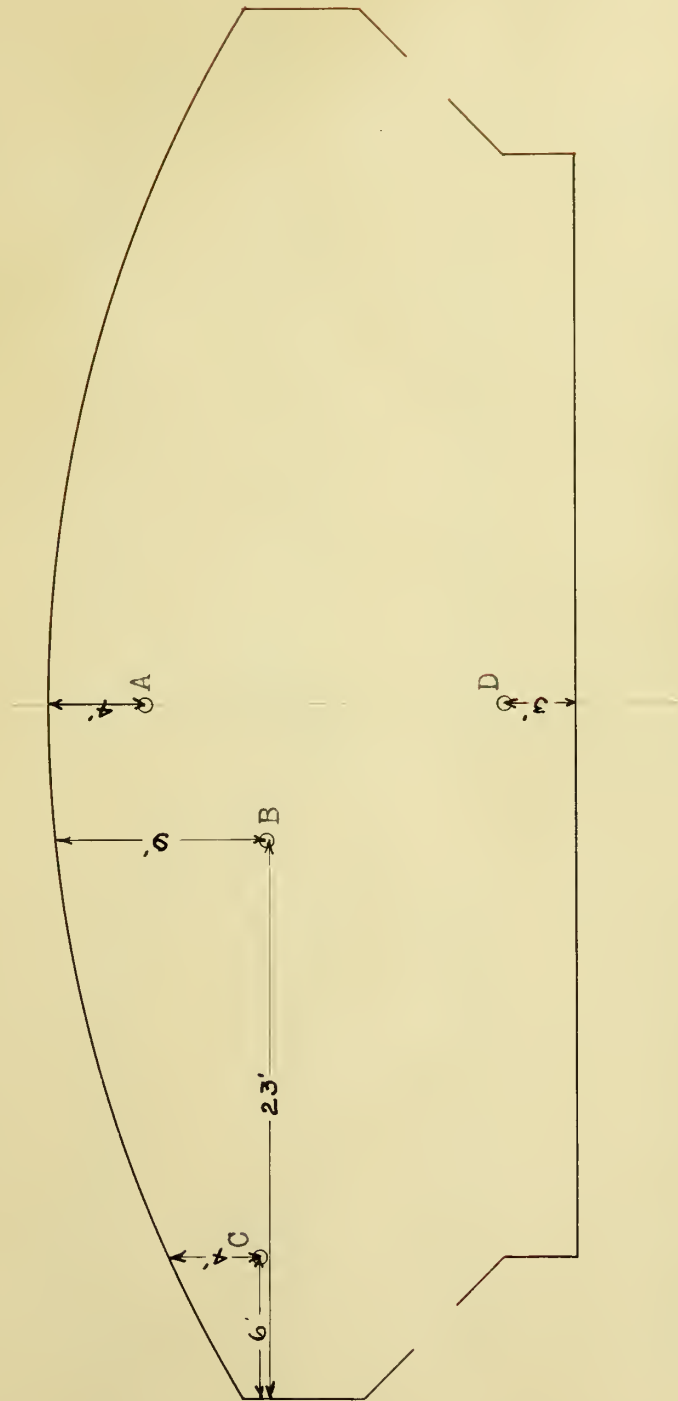
PLAN OF STAGE

It was not thought necessary to take a great number of positions on the stage from which to take readings, so that a few were selected which cover almost any condition. Referring to the drawing of the stage plan on page 25 position "A" is the place usually occupied by the pulpit or

reading stand; position "B" was directly under one of the lights; position "C" was an extreme position only used at the time of Choral Concerts or other similar numbers; and position "D" was in the middle of the back of the stage. At positions "A" and "C" it is seen that the intensity from the general illumination or dome fixtures is about as great as that from the stage fixtures. These readings were taken on a plane about four feet above the floor, which is about the place that the average person holds a book when standing. These data also show very non-uniform lighting over the stage which is very undesirable.
